Appendix A
PAVEMENT CONDITION SUMMARY
Colorado Springs Airport

Applied Pavement Technology, Inc.

October 2010

Pavement Condition Summary

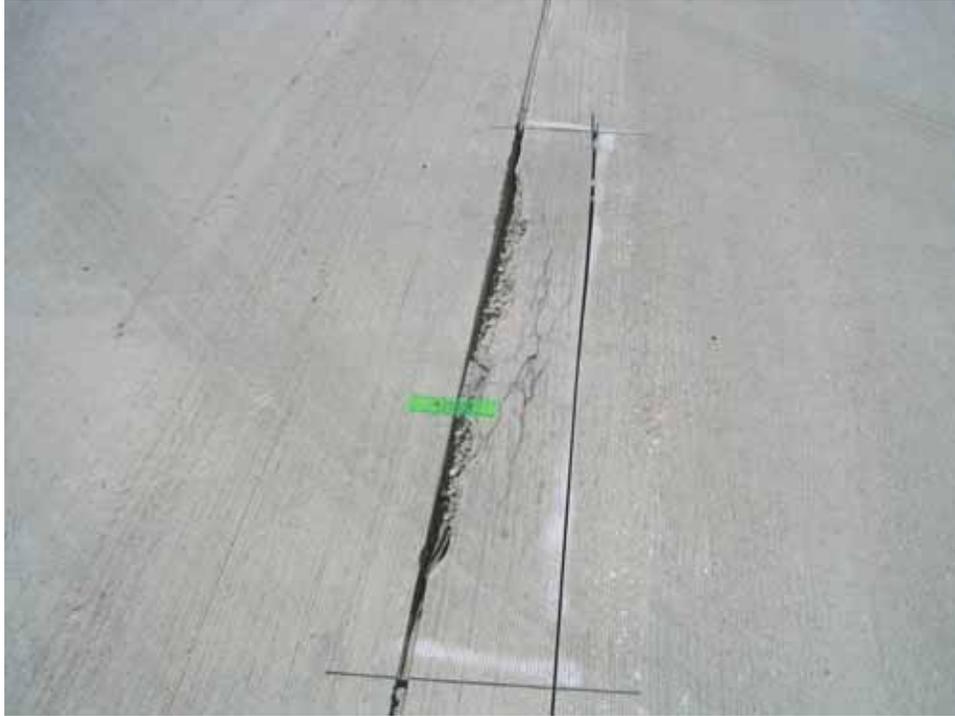
Figure 1. A01CS-01 Joint Spall

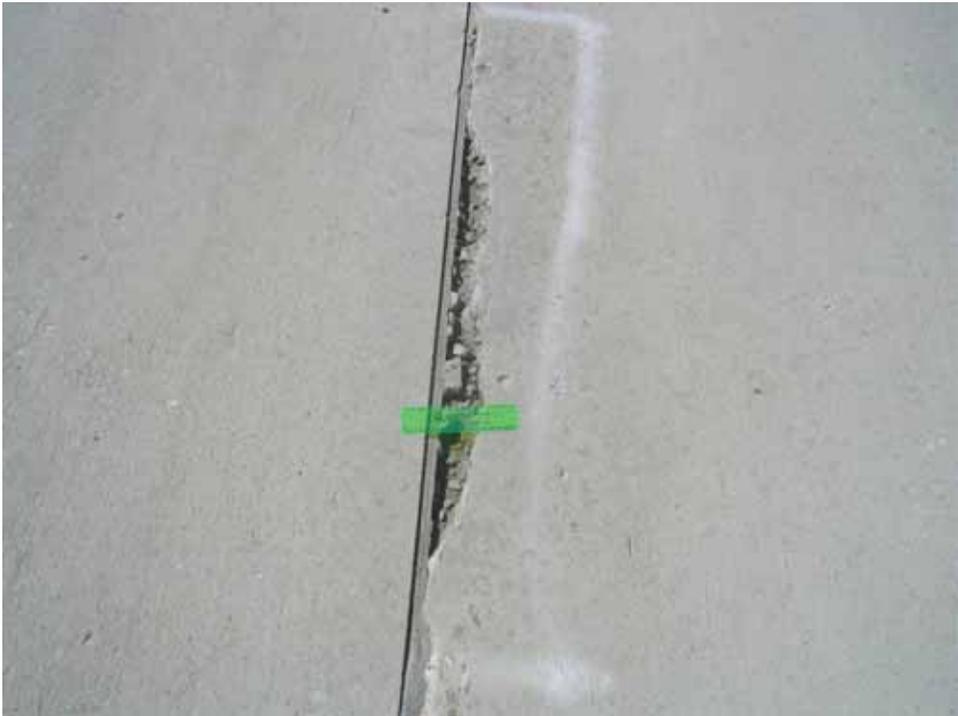
Figure 4. A01CS-03 Joint Spall

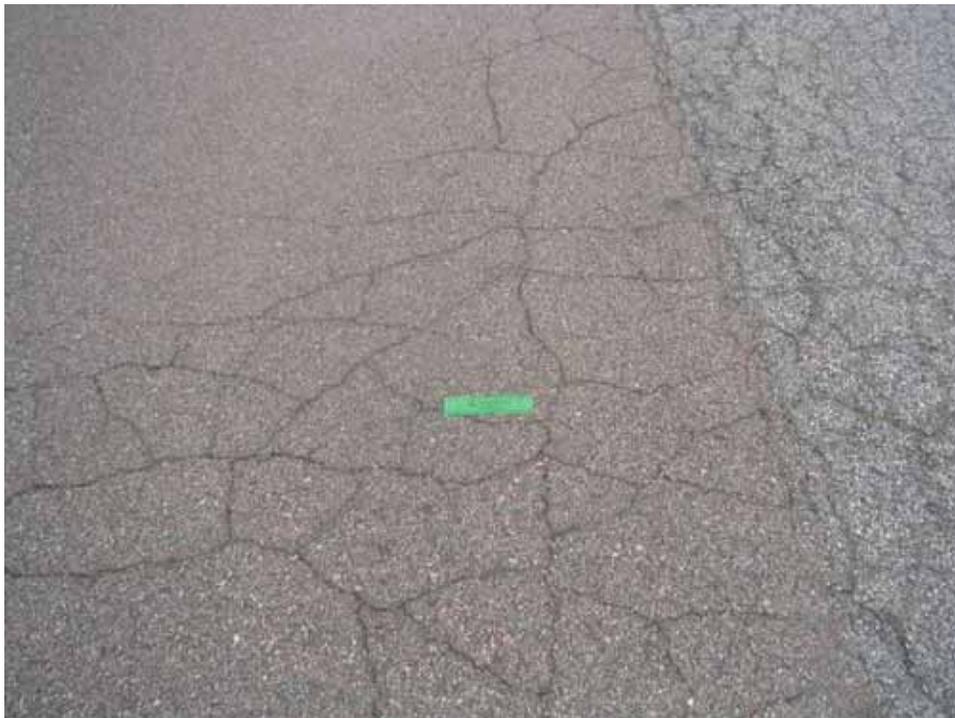
Figure 6. A02CS-04 Alligator Cracking

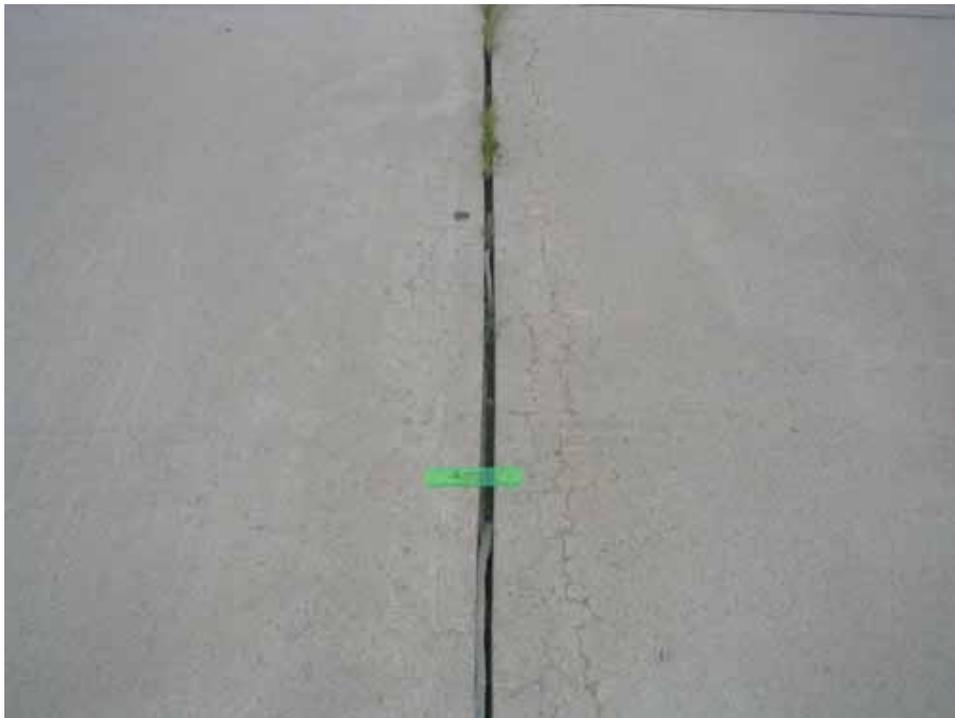
Figure 8. A02CS-10 Joint Seal Damage

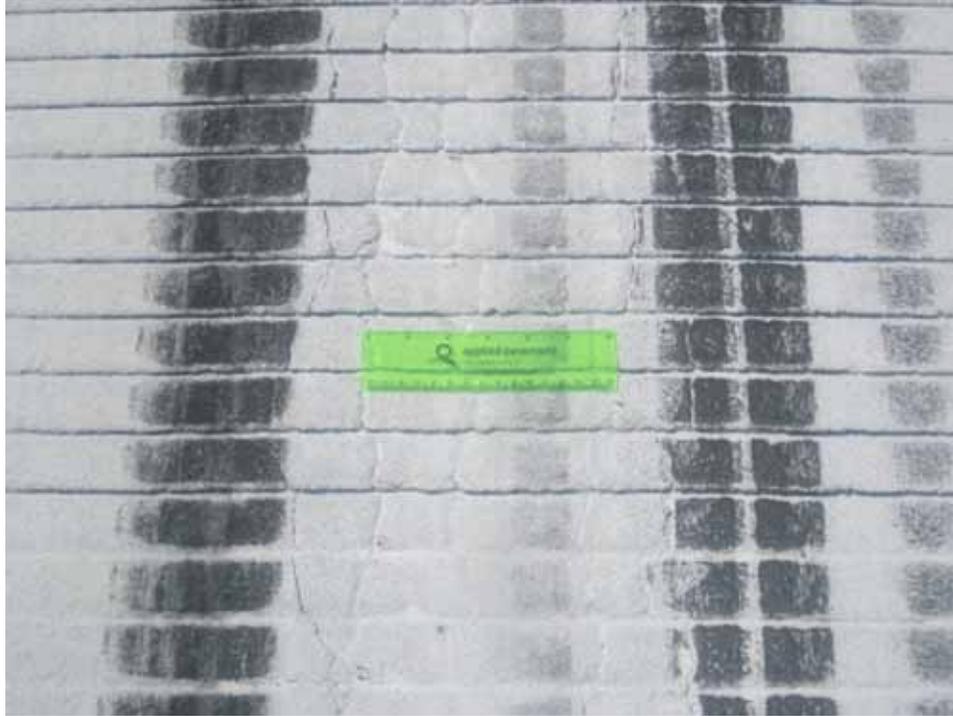
Figure 17. R17RCS-01 Alligator Cracking

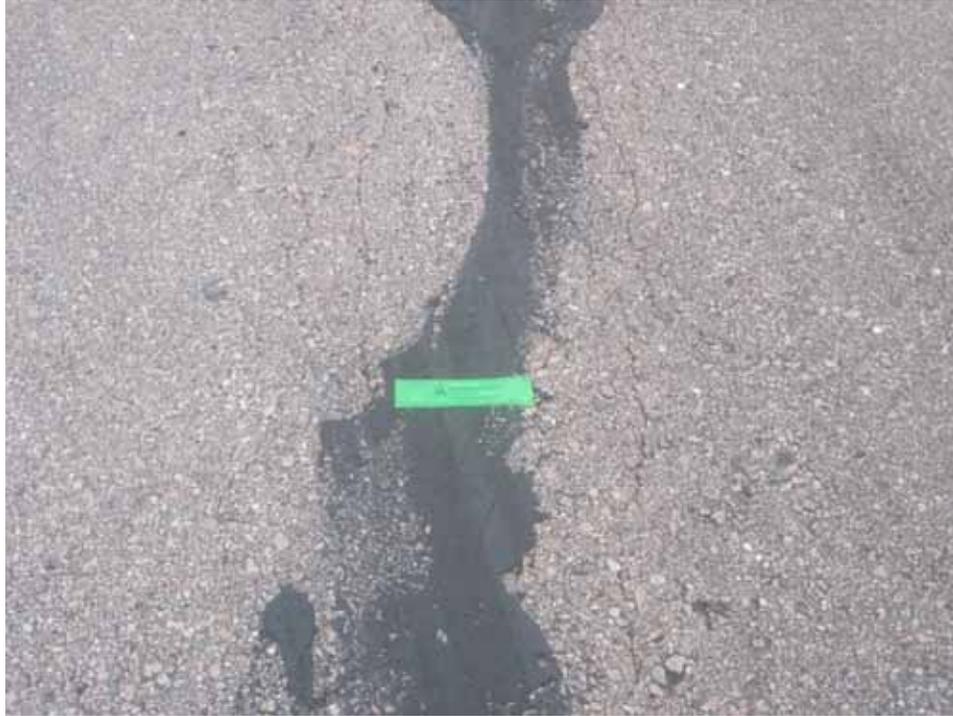
Figure 37. TACS-01 Alligator Cracking

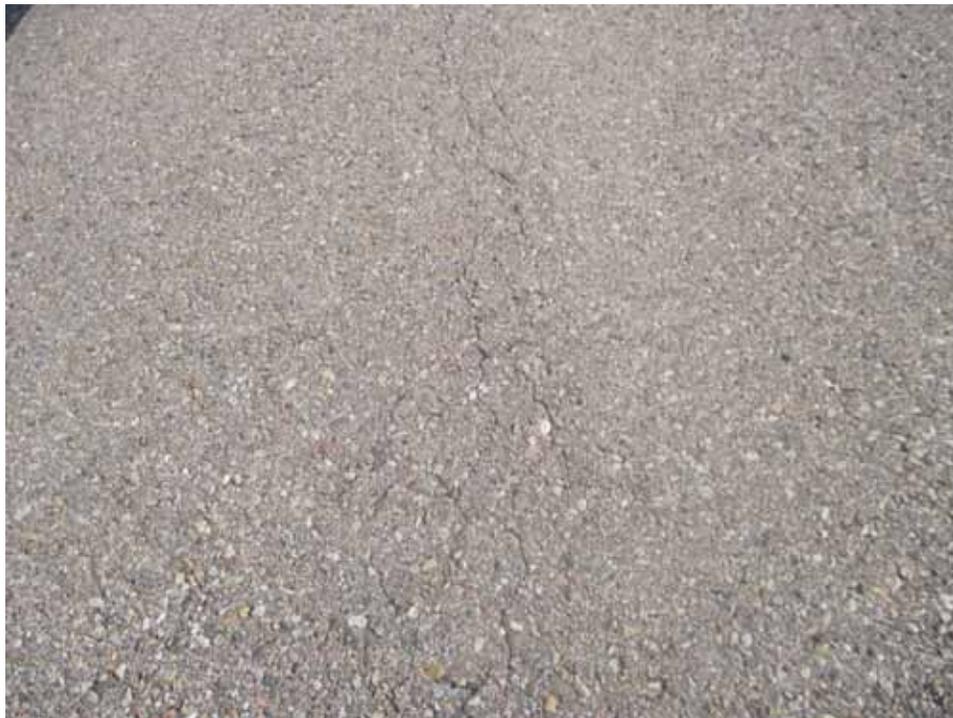
Figure 46. TB6CS-01 Alligator Cracking

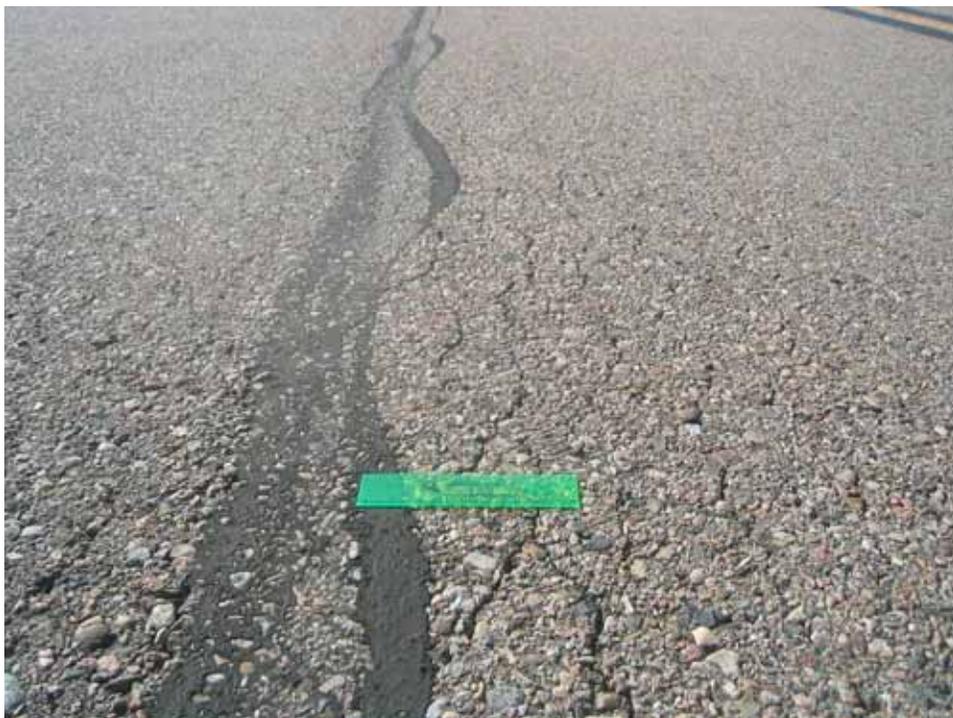
Figure 48. TBCS-01 Alligator Cracking

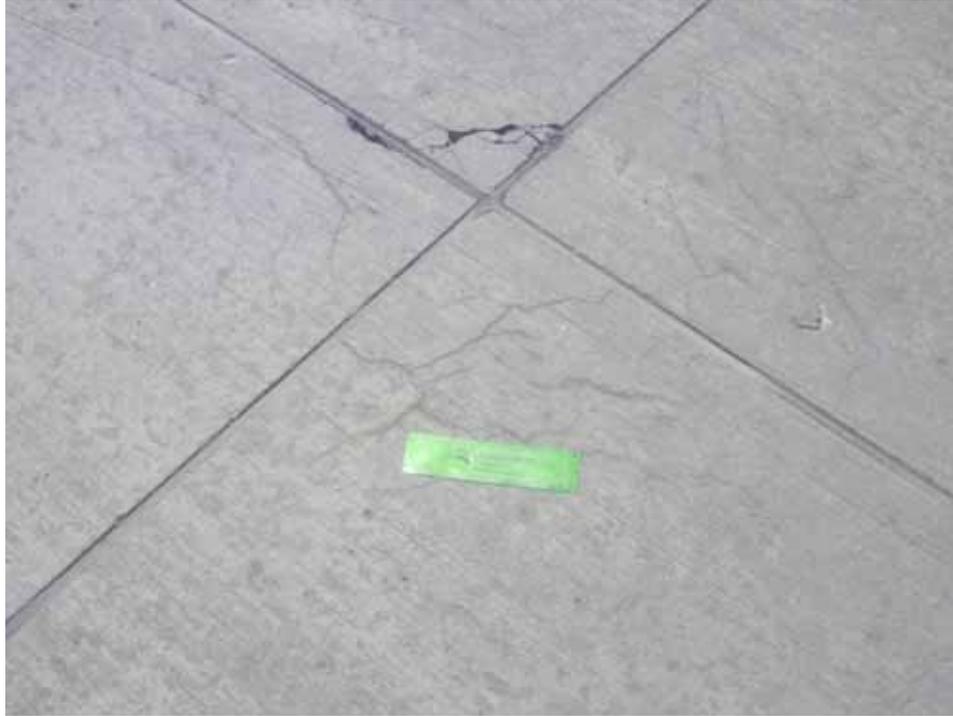
Figure 59. TC3CS-02 Durability Cracking

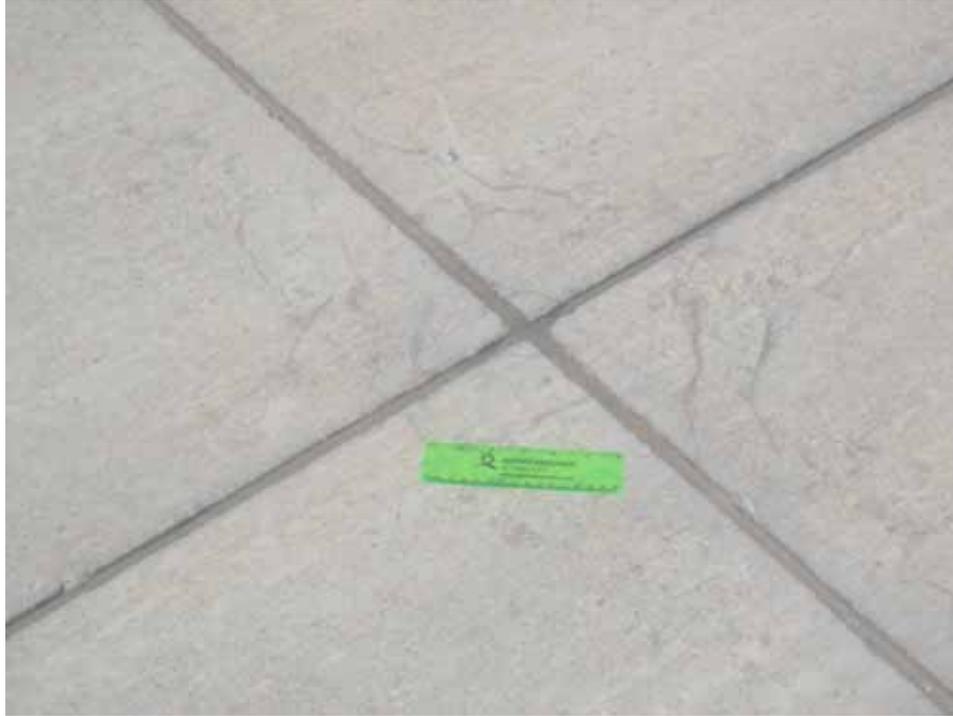
Figure 63. TC5CS-01 Durability Cracking

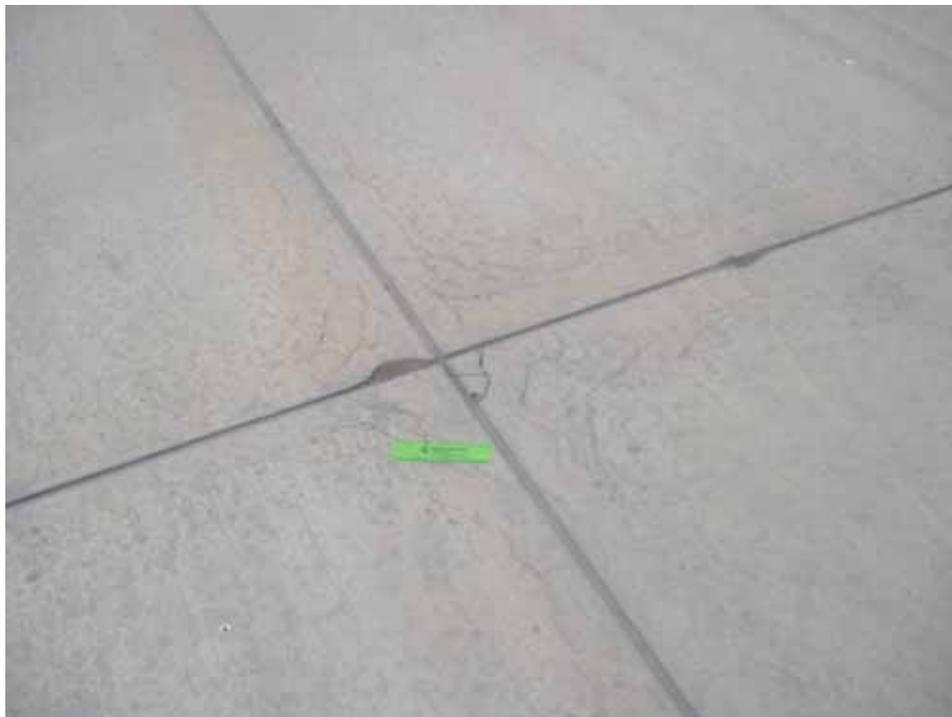
Figure 67. TC6CS-01 Durability Cracking

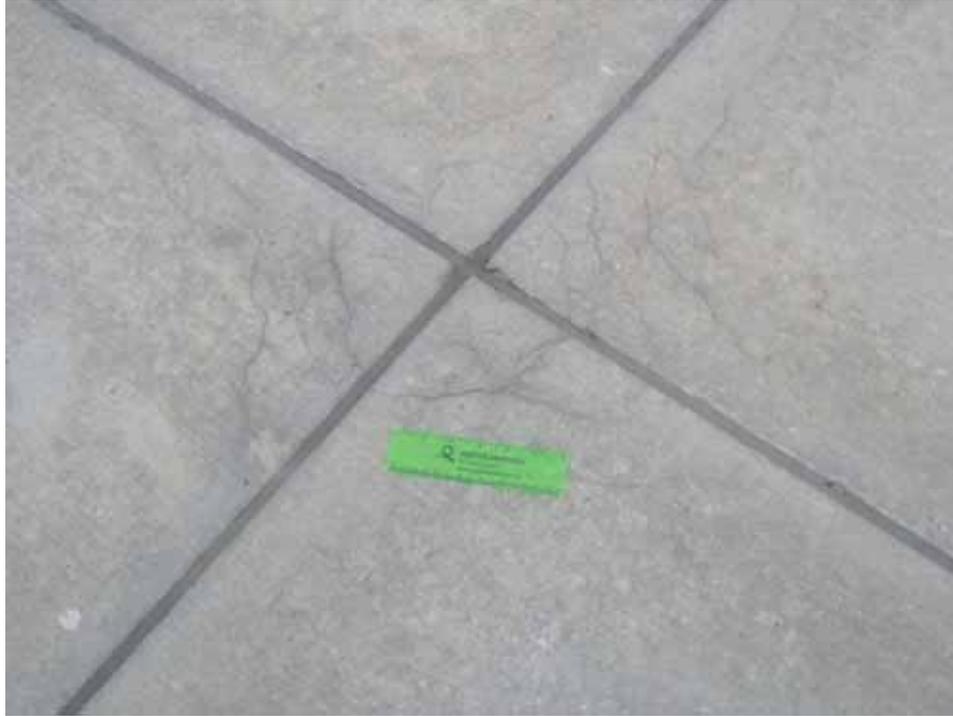
Figure 69. TC7CS-01 Durability Cracking

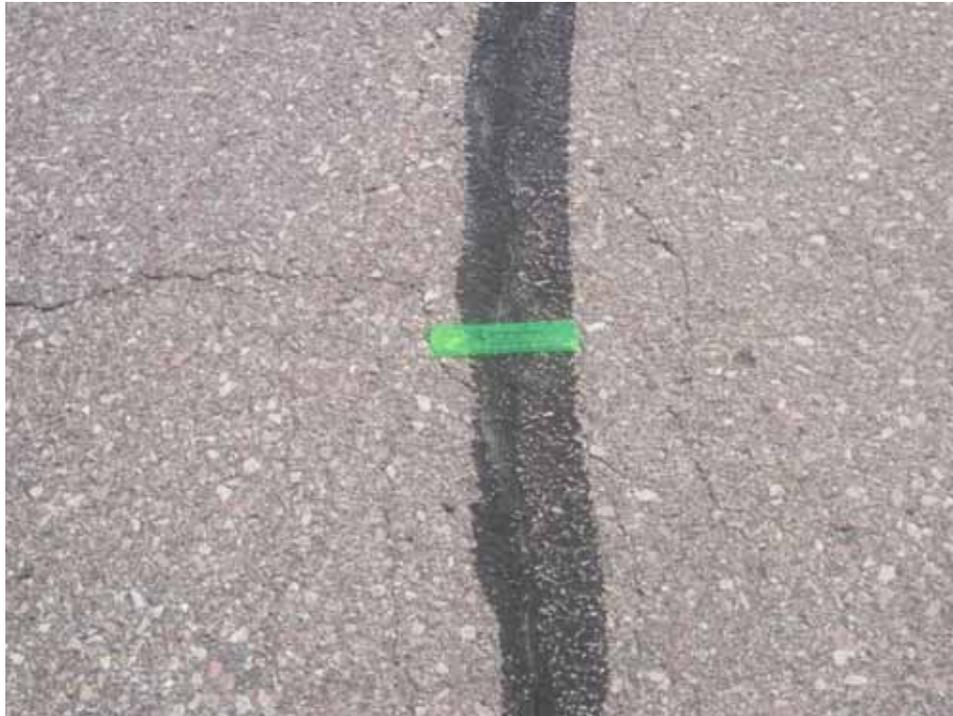
Figure 71. TC7CS-02 Alligator Cracking (1)

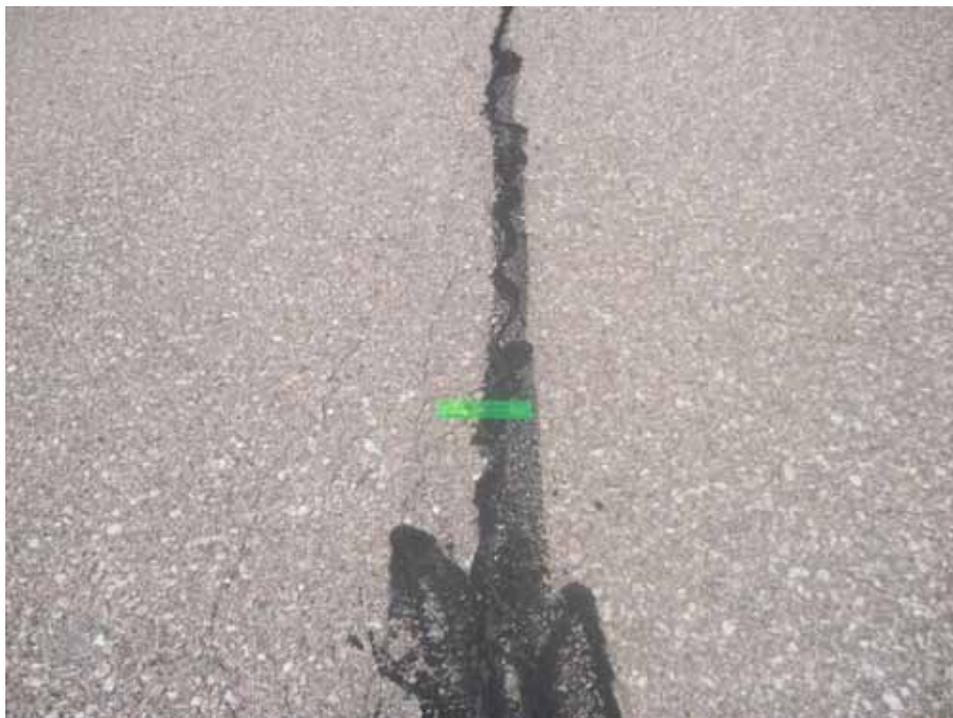
Figure 72. TC7CS-02 Alligator Cracking (2)

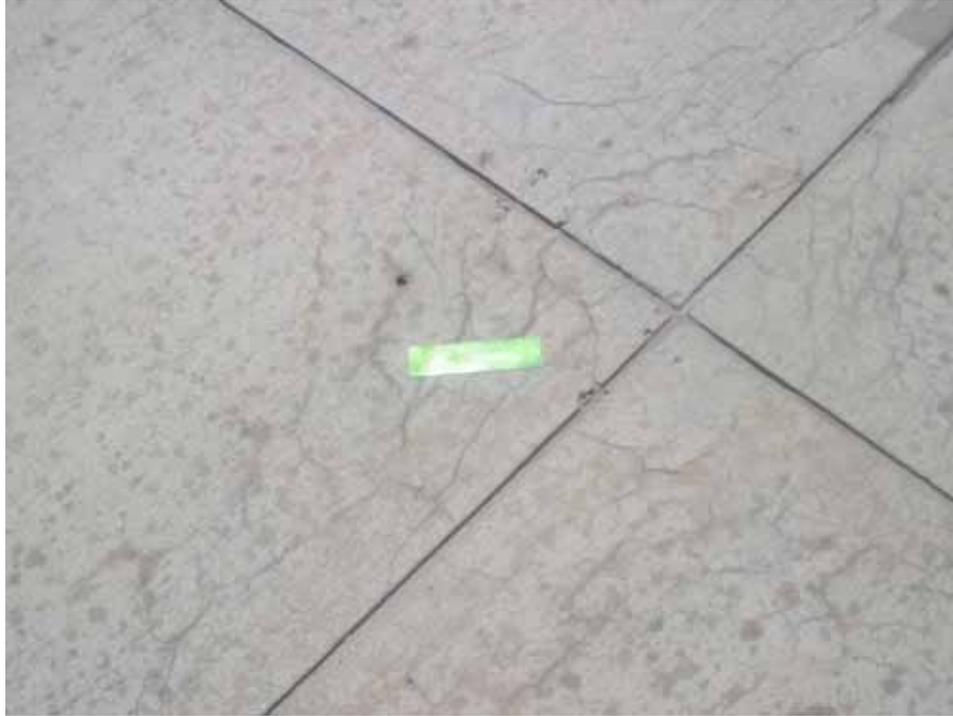
Figure 79. TE2CS-01 Durability Cracking

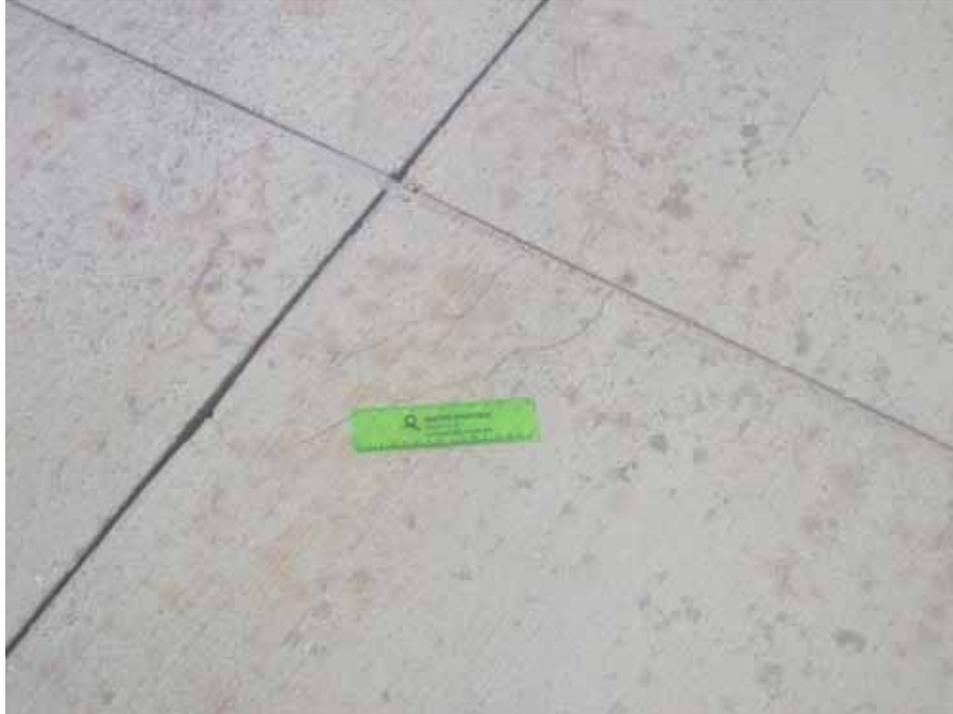
Figure 81. TE3CS-01 Durability Cracking

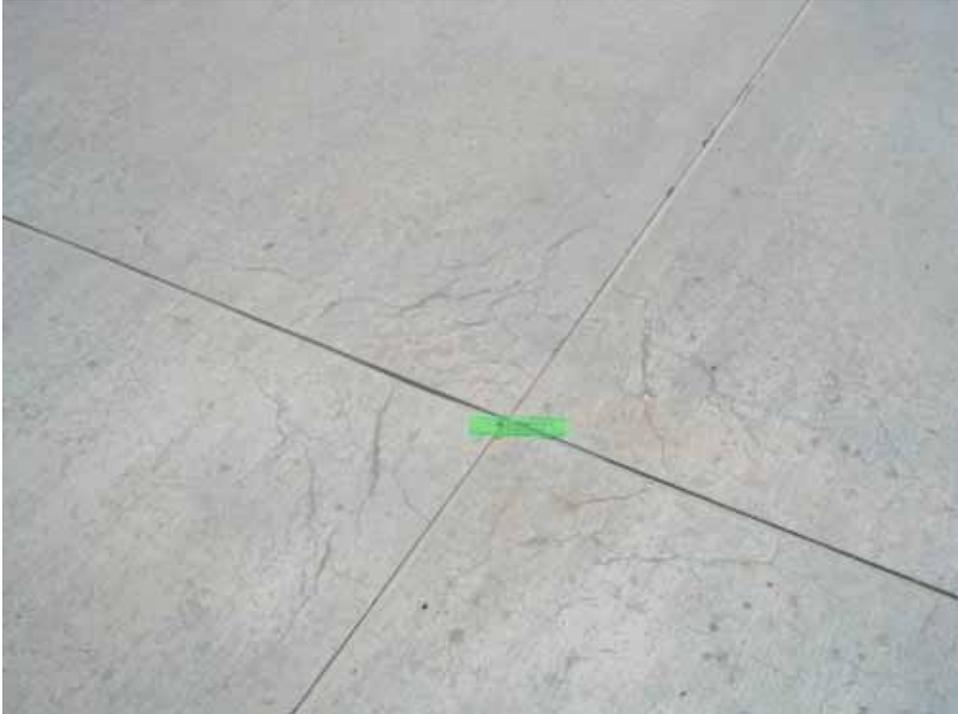
Figure 83. TE6CS-01 Durability Cracking

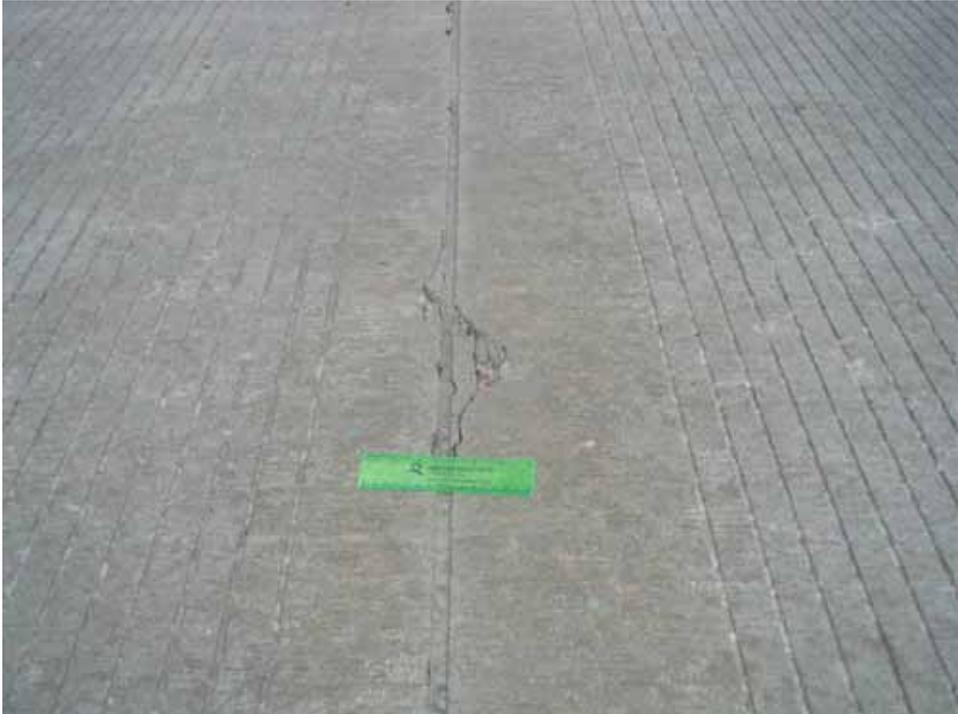
Figure 84. TE6CS-01 Joint Spall

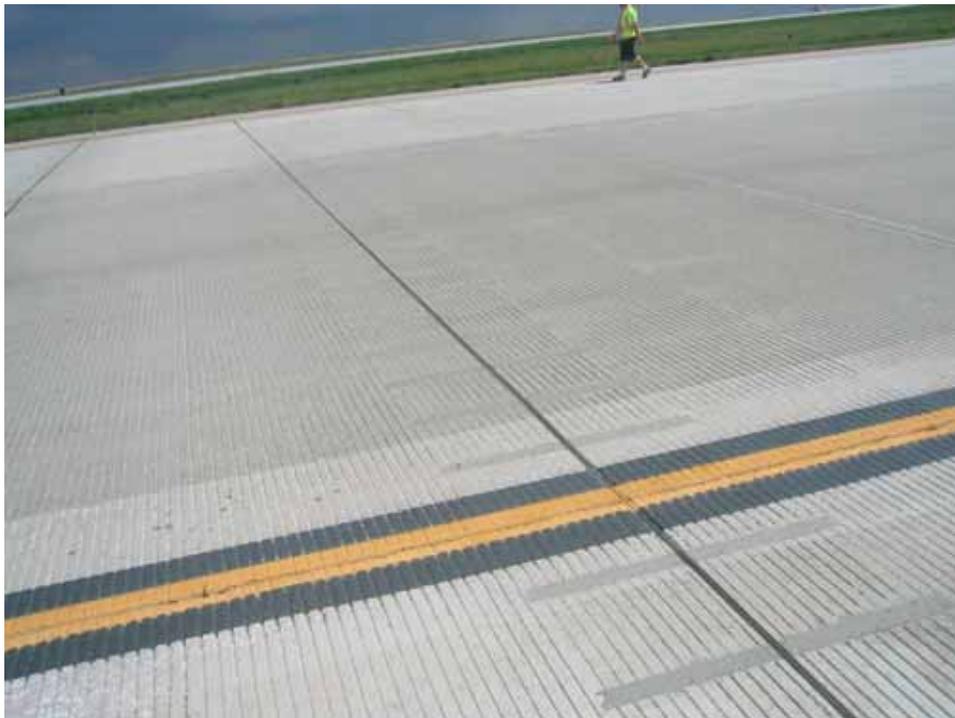
Figure 86. TE6CS-01 Repair

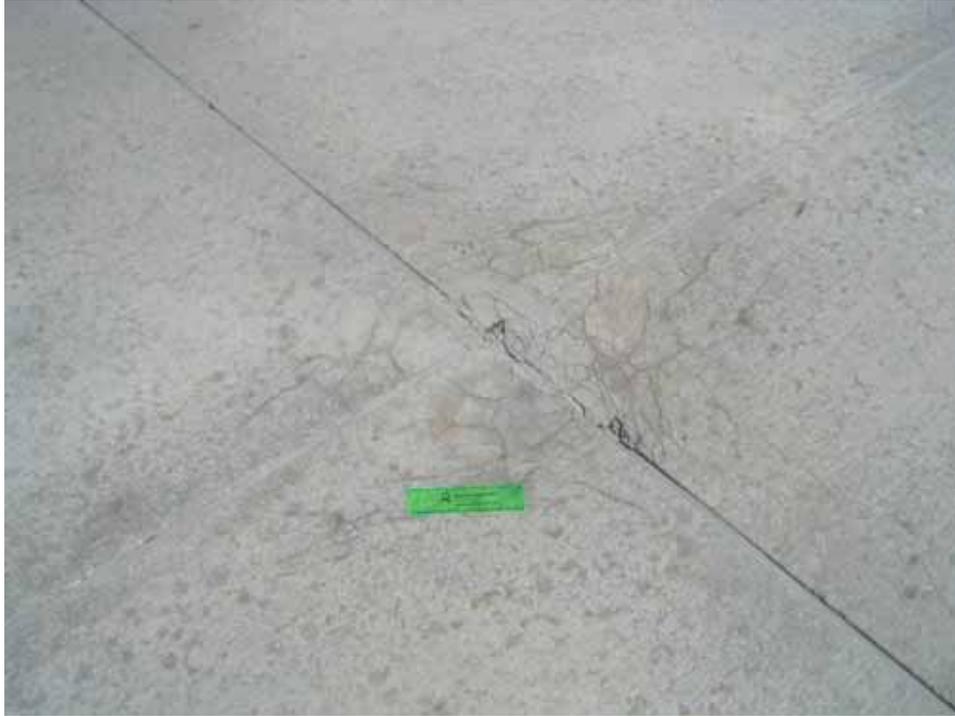
Figure 89. TECS-02 Durability Cracking

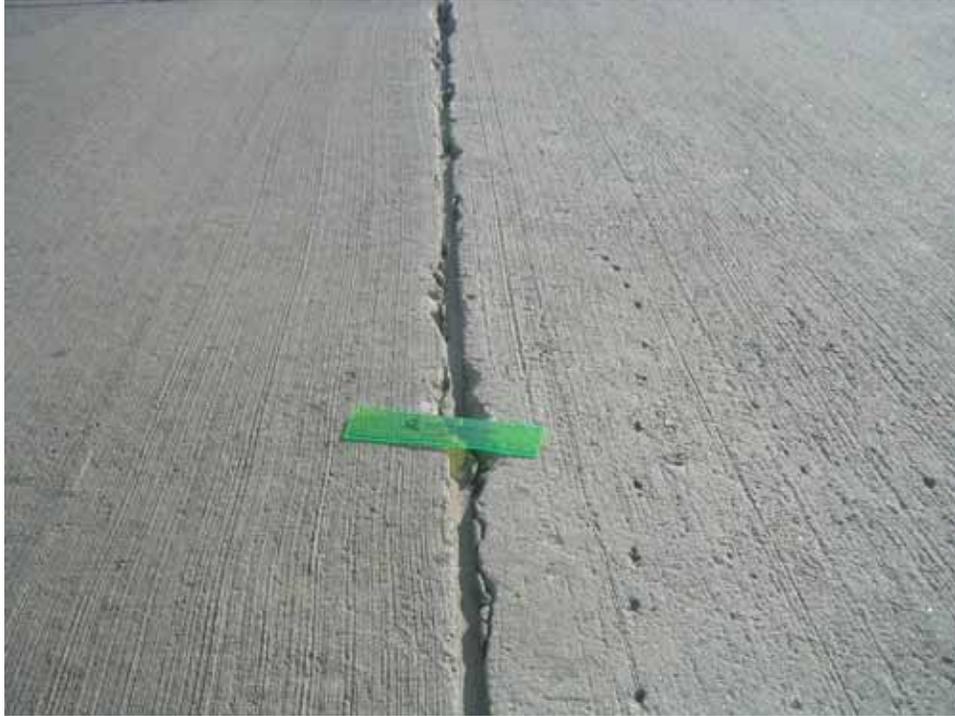
Figure 93. TFCS-01 Joint Spall (fraying)

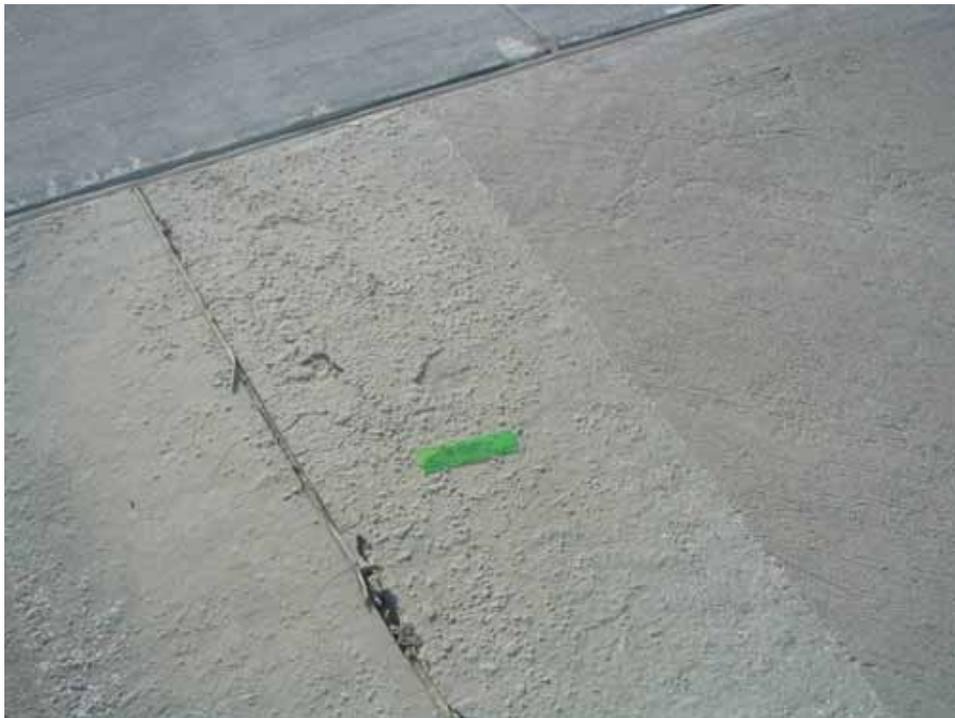
Figure 94. TFCS-01 Large Patch

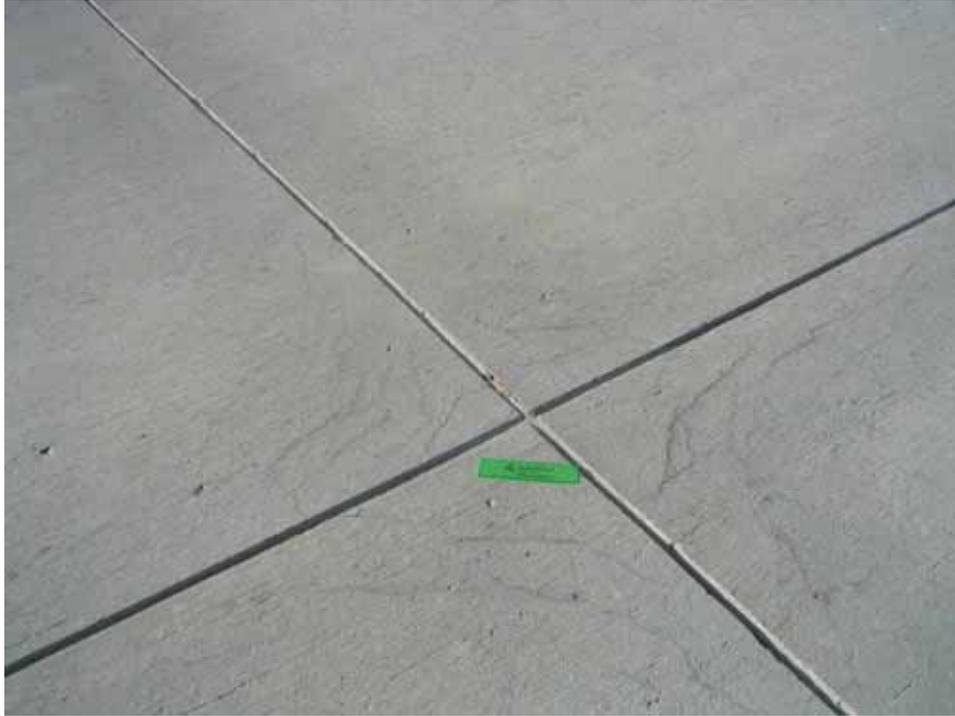
Figure 97. TFCS-03 Durability Cracking

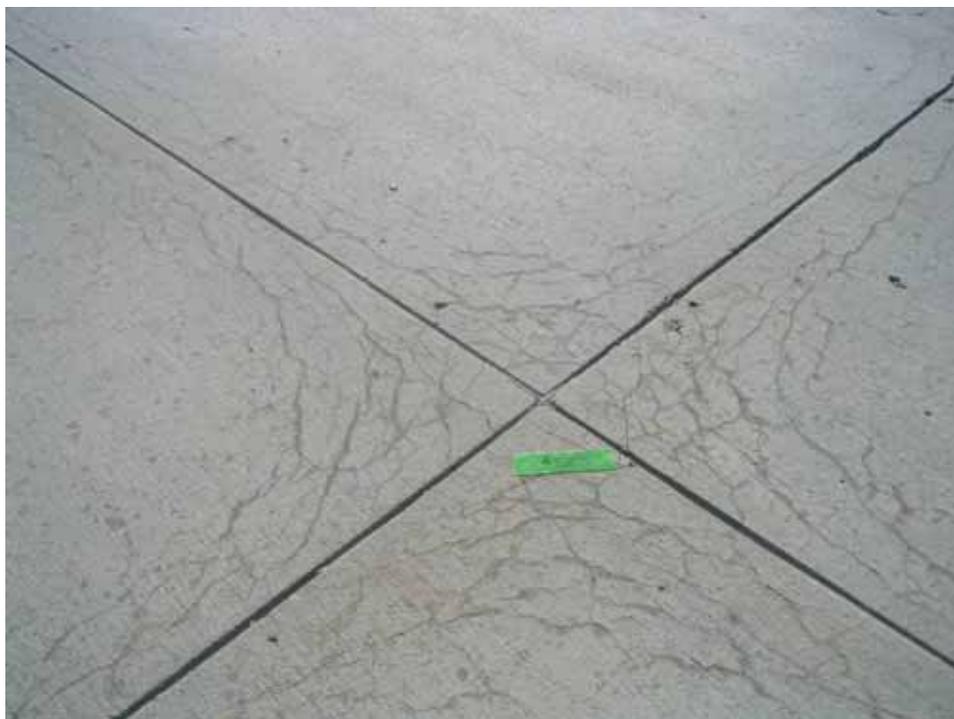
Figure 99. TFCS-04 Durability Cracking

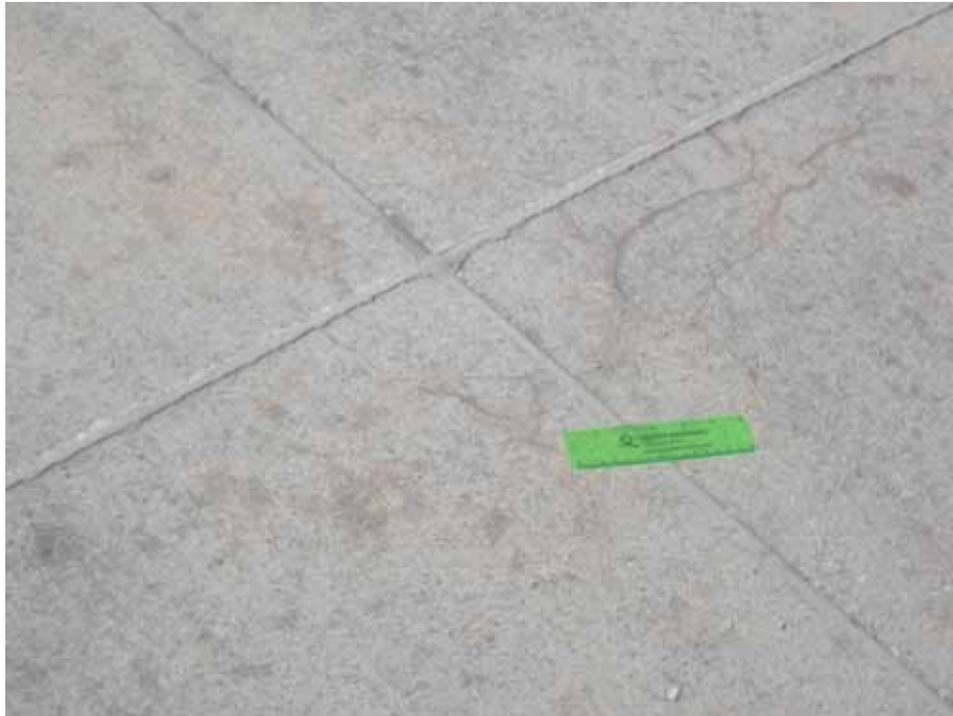
Figure 103. TGCS-03 Durability Cracking

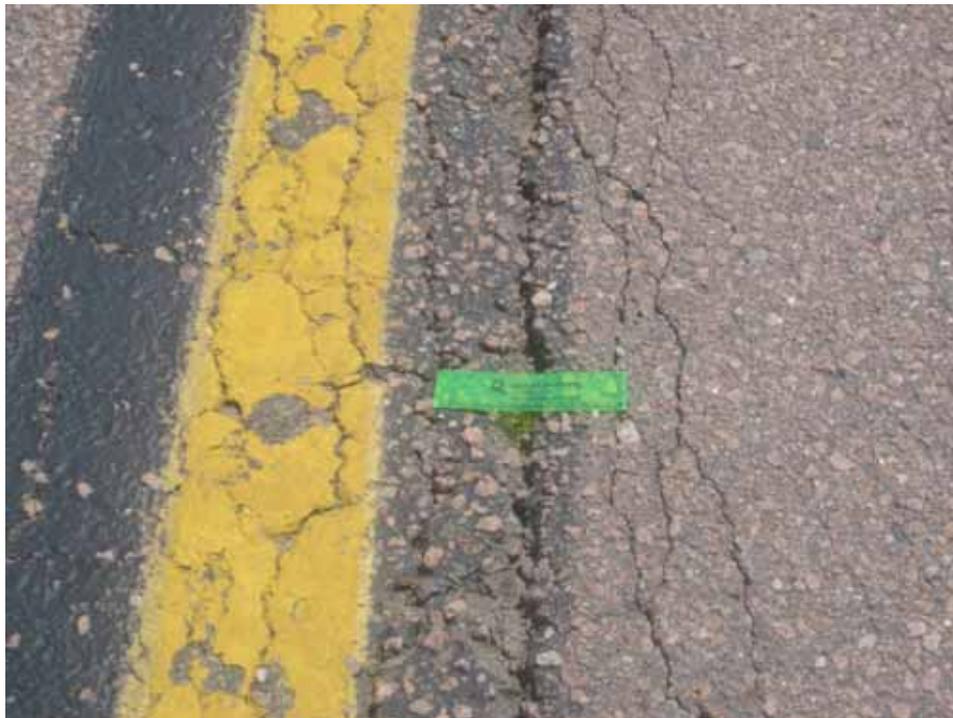
Figure 106. TGCS-05 Alligator Cracking

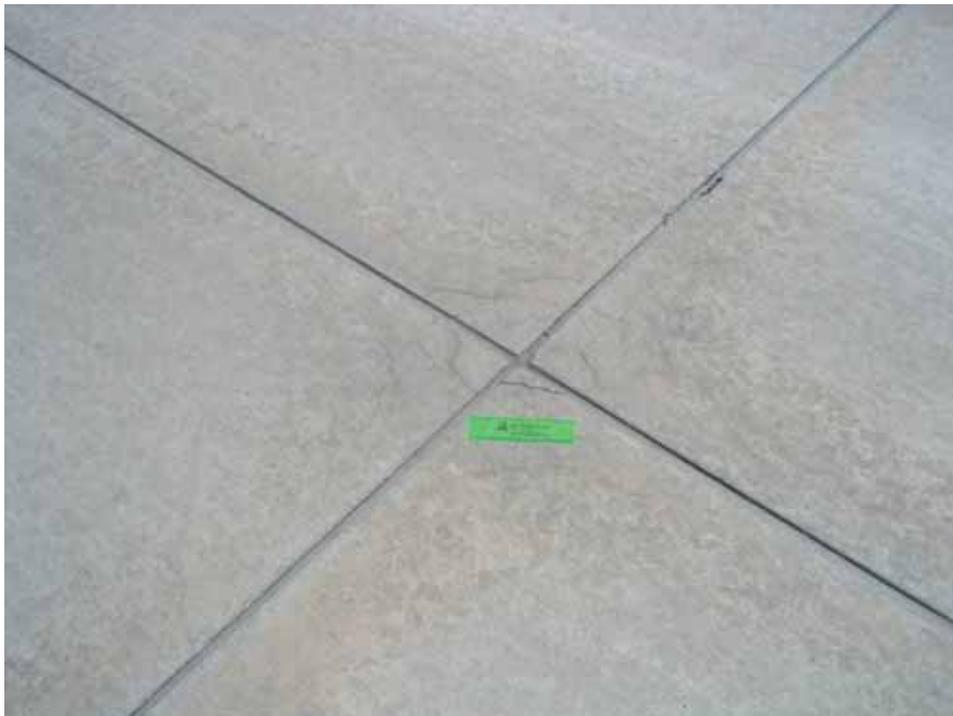
Figure 110. THCS-02 Durability Cracking

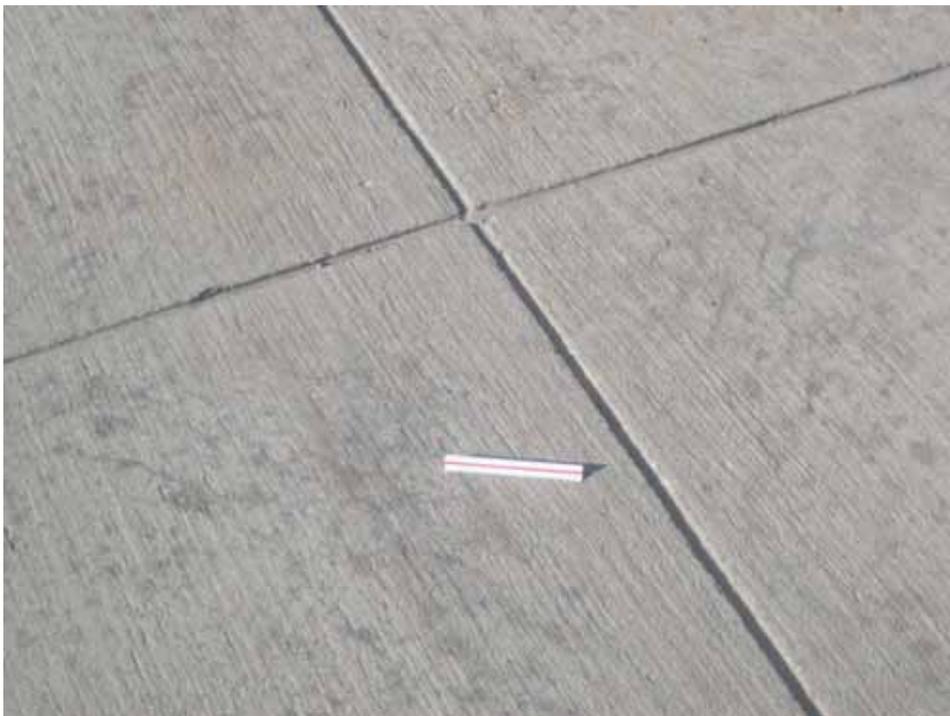
Figure 116. TMCS-01 Durability Cracking
