Appendix A
PAVEMENT CONDITION SUMMARY
Colorado Springs Airport

Applied Pavement Technology, Inc.

October 2010

Pavement Condition Summary

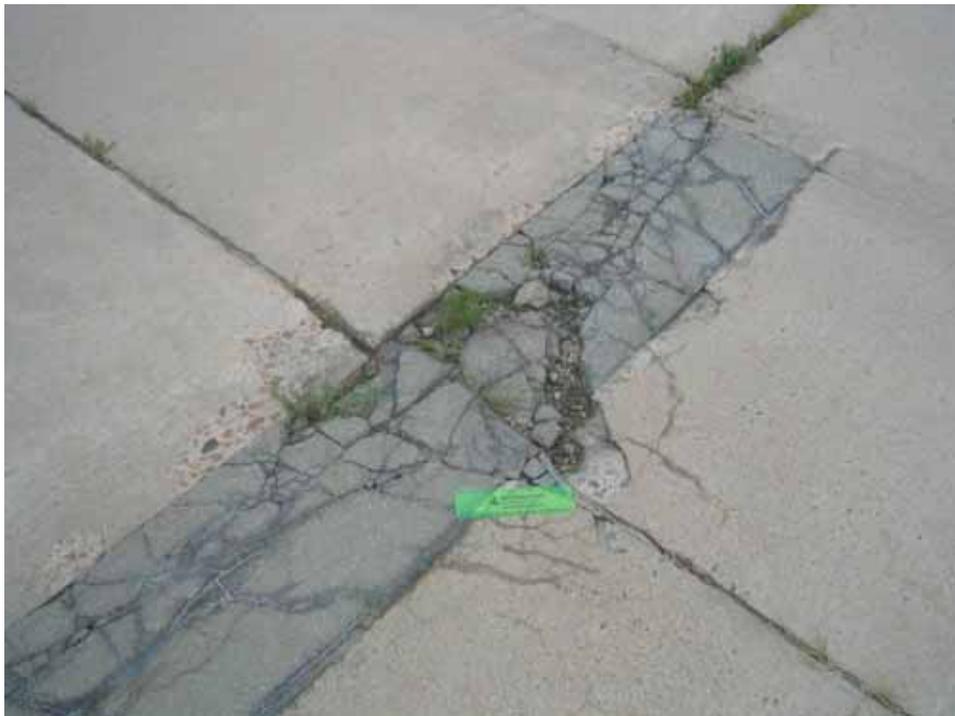
Figure 10. A02CS-10 Small Patch

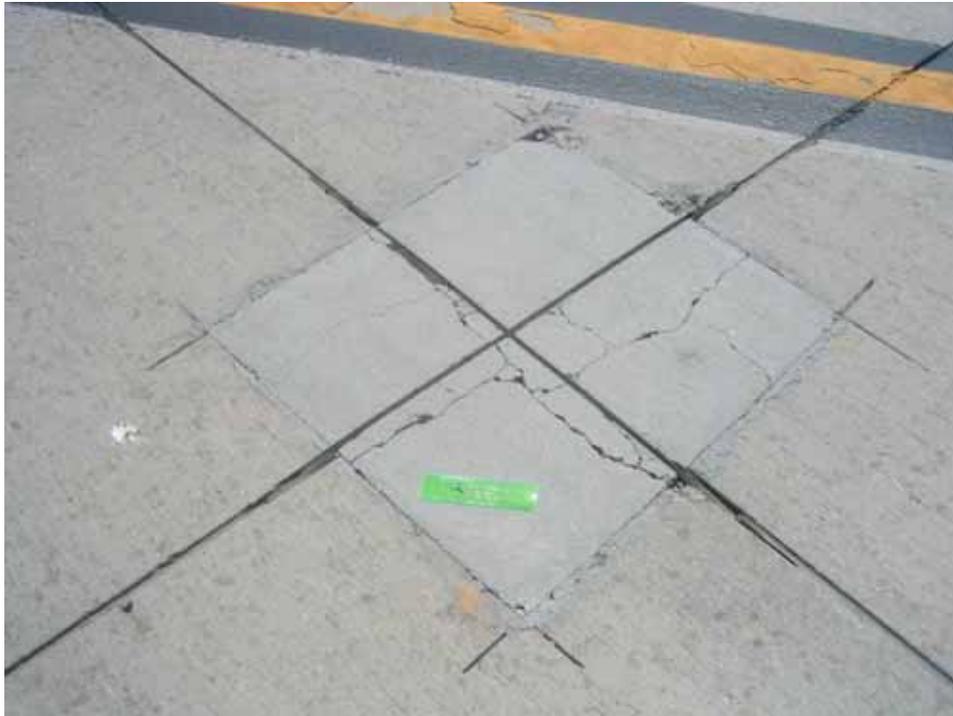
Figure 91. TECS-02 Small Patch

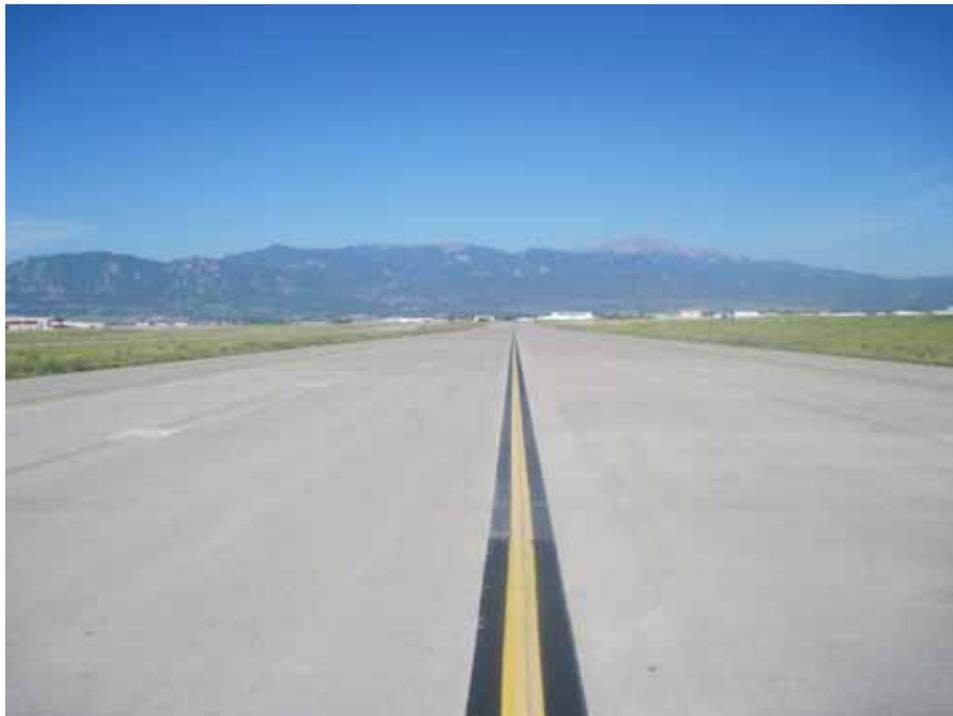
Figure 102. TGCS-02 To Be Rehabilitated

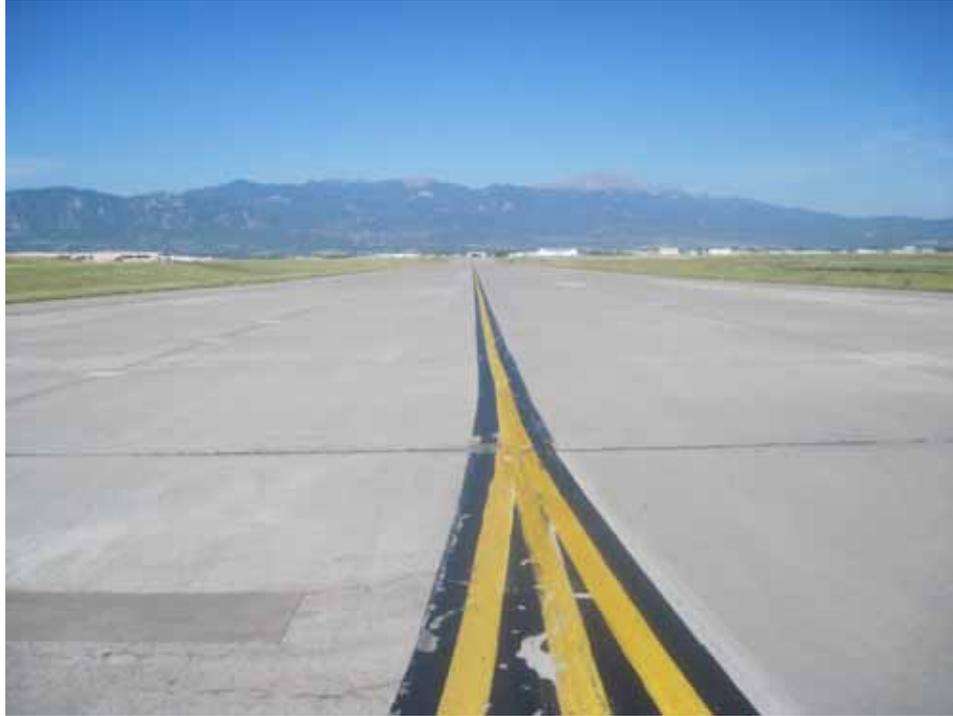
Figure 109. THCS-01 To Be Rehabilitated
